# FLOODING FROM STORM DENNIS IN SHREWSBURY, UK

FLOOD BRIEFING SERIES  
WITH ICEYE SAR SATELLITE CONSTELLATION DATA

Release Date: January 19<sup>th</sup>, 2021

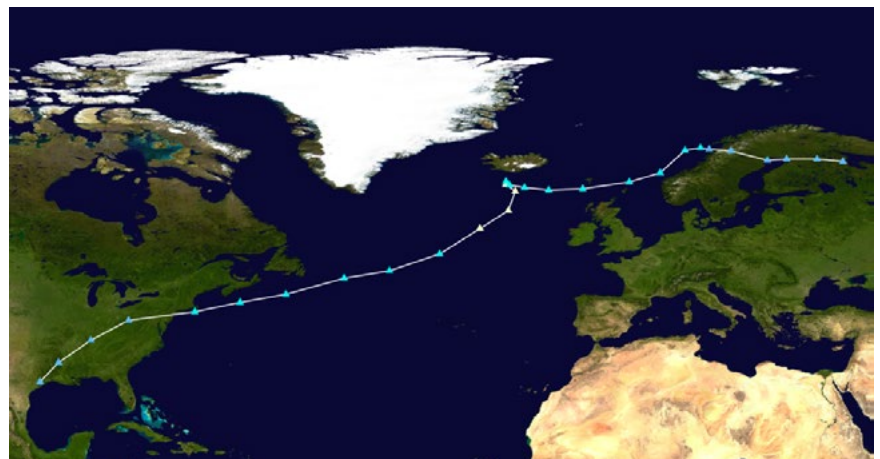
Track map of Storm Dennis of the 2019-20 European windstorm season.

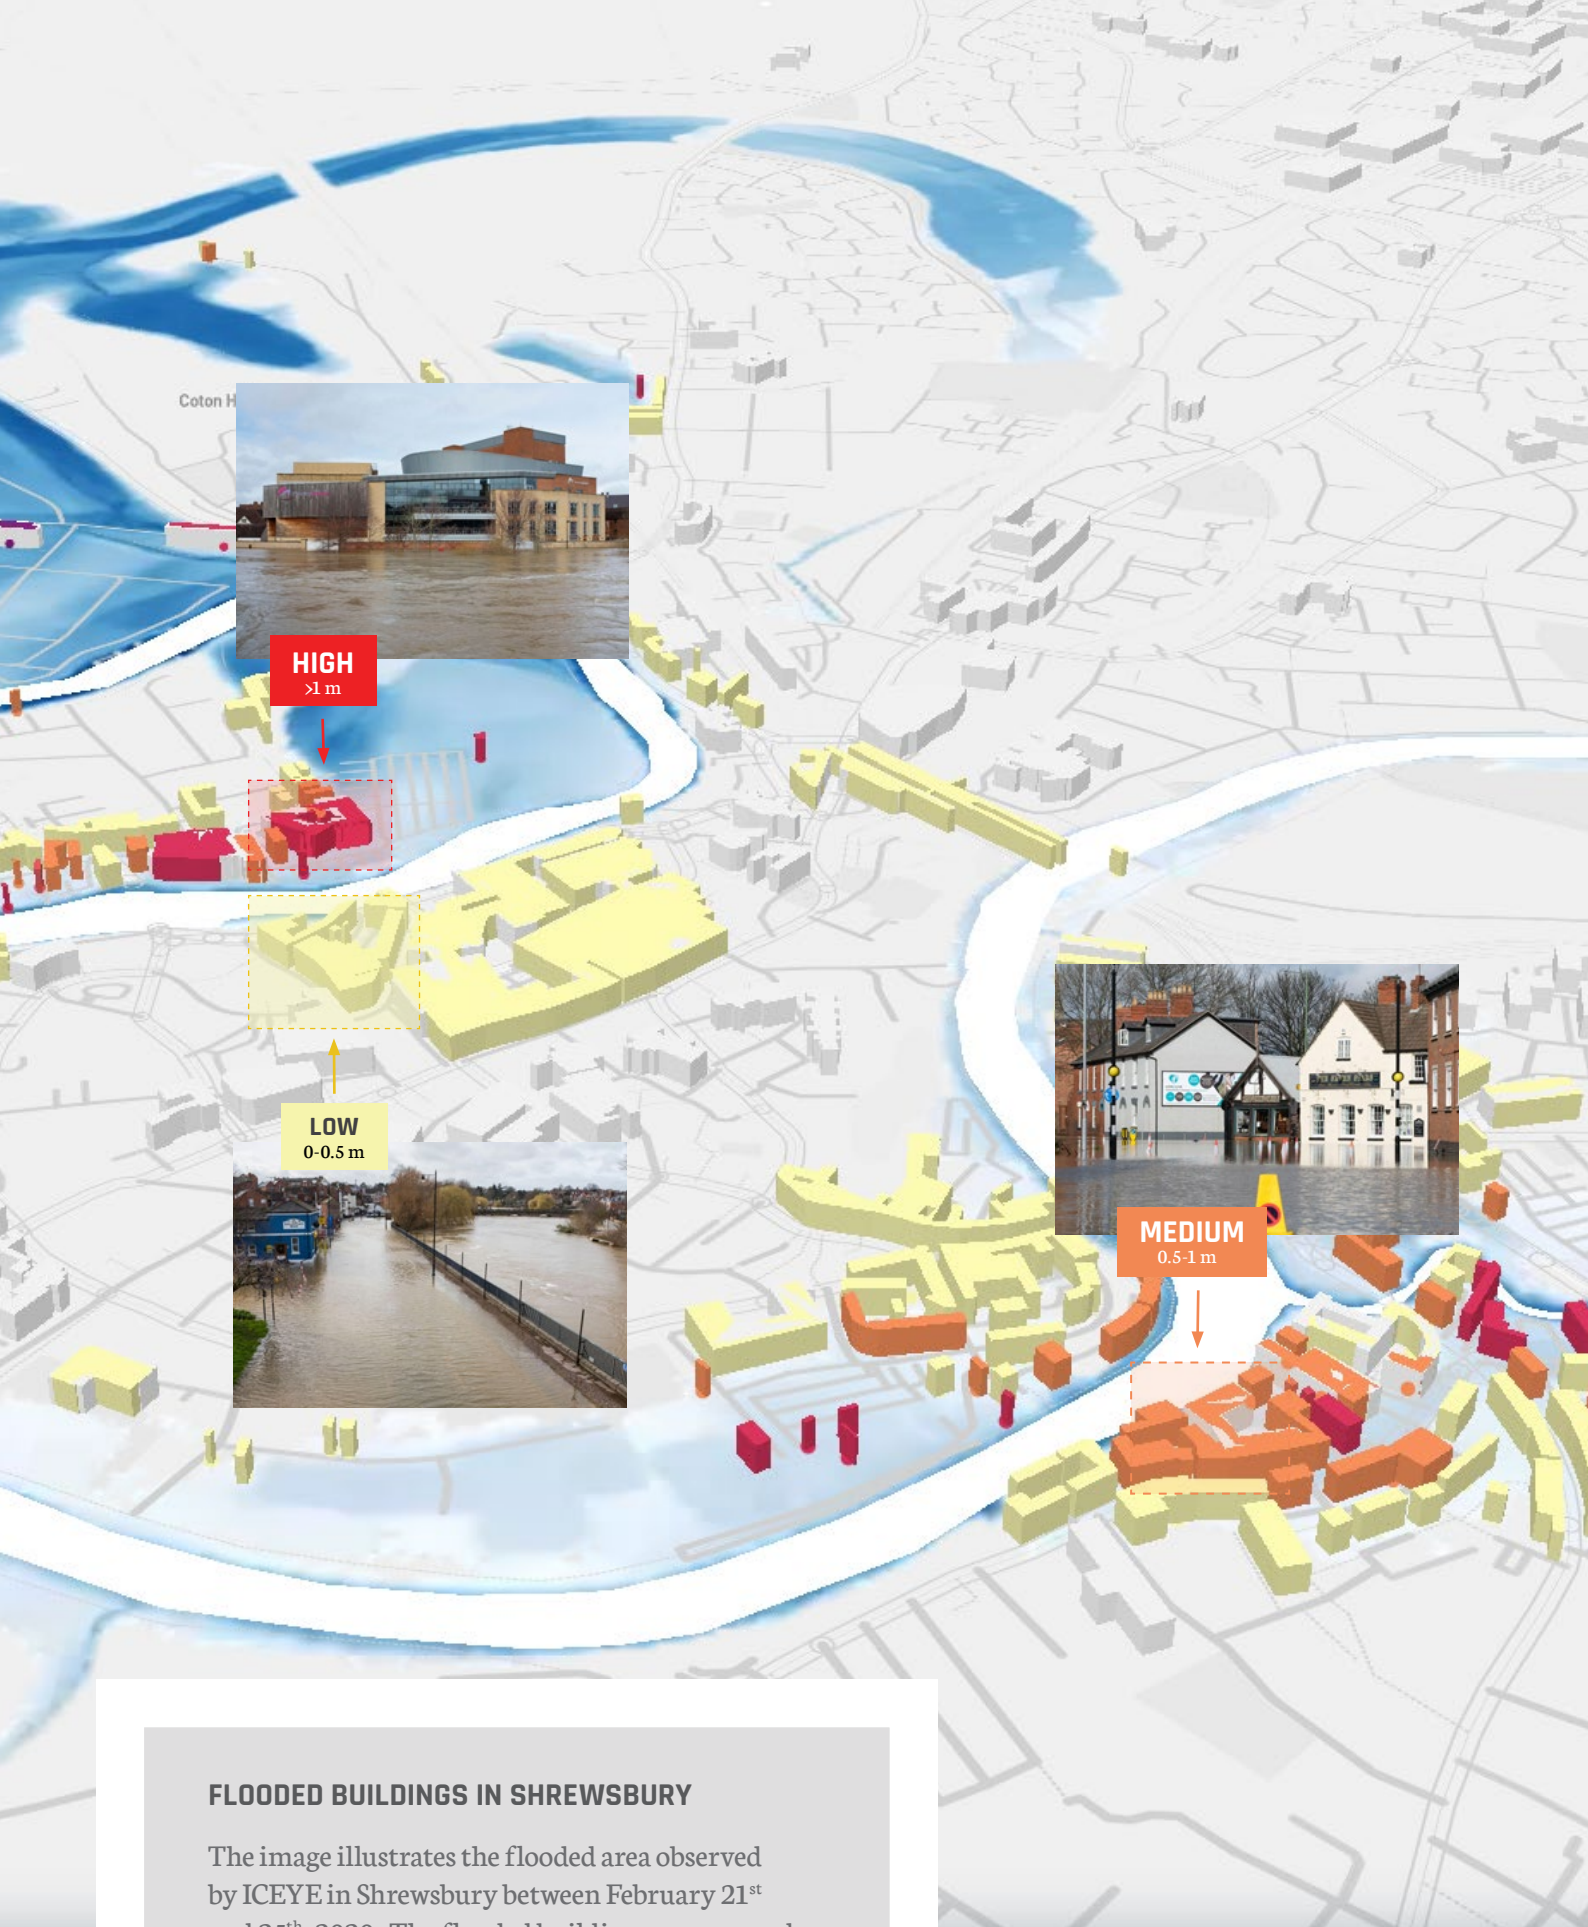
### FLOODED BUILDINGS IN SHREWSBURY

The image illustrates the flooded area observed by ICEYE in Shrewsbury between February 21<sup>st</sup> and 25<sup>th</sup>, 2020. The flooded buildings are grouped into 3 different classes by the depth levels: low (0-0.5 m), medium (0.5-1 m) and high (>1 m).

The impact of the flood analysis was quantified by using building footprint information. Large parts of the Shropshire County were flooded; more than **200 km<sup>2</sup>** of the observed area were inundated to a depth of up to 5 m. According to the building footprint information, **over 450 buildings** in Shropshire were affected. 220 buildings were flooded with more than a half meter of water. The maximum building flood depth was approx. **3 m**. The average depth of the flooded coverage was about **0.45 m**.
